15 November 2023
Document Id. 23135C-01L1
Serial No. 20561

**SUBJECT: LIMITED ENGINEERING SERVICES
SUMMARY OF ROADWAY CONDITIONS
HIGUERA ROAD
SANTA CLARA COUNTY, CALIFORNIA**

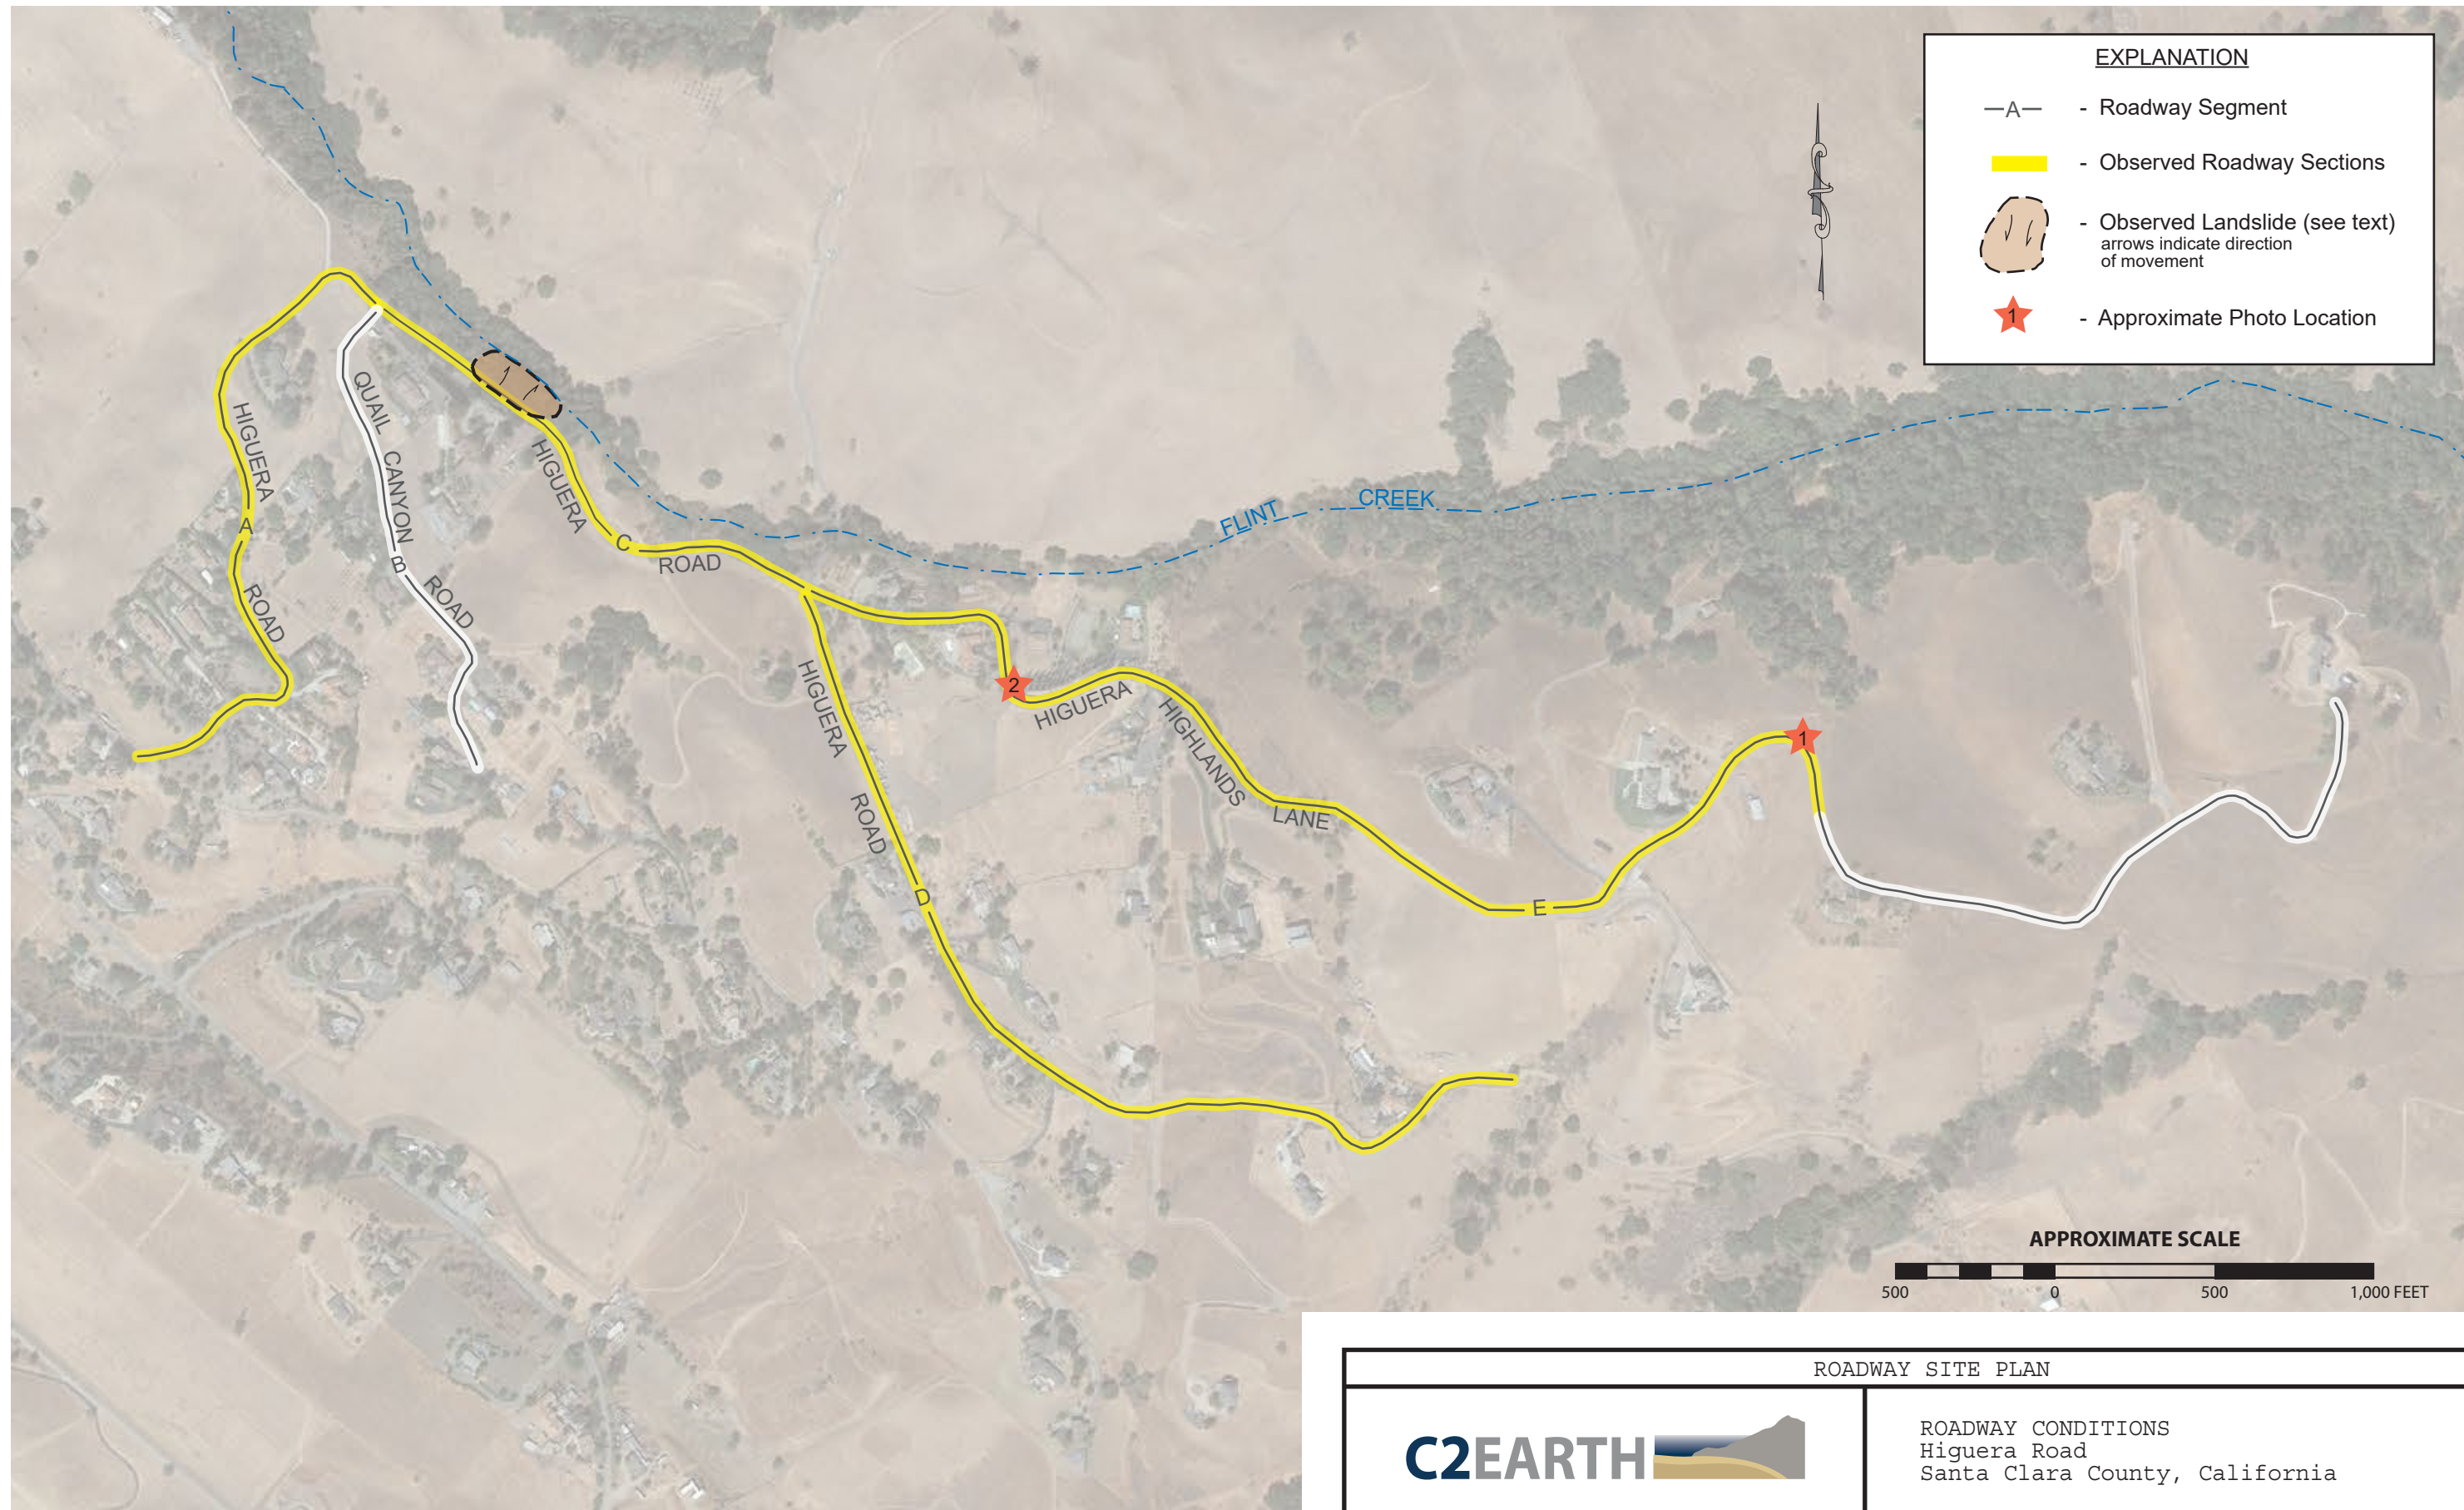
ROADWAY SITE PLAN				
C2EARTH

We also observed longitudinal cracking and uneven pavement along an approximately 400-foot long section of roadway (on Segment C between the intersection with Sections B and D). From the downhill side of the roadway, the adjacent ground surface descends steeply into Flint Creek. The vertical elevation difference between the roadway and creek is about 50 feet. Based upon the pattern of cracking and the steep terrain, the damage appears to be the result of incipient landsliding. A landslide hazard evaluation is warranted to characterize the subsurface conditions and to develop recommendations to mitigate the potential for further damage or destruction of the roadway.

The landslide affecting the roadway presents an imminent hazard. Landslide movement could damage or destroy the roadway and impede egress to the area, however, we understand that there is an alternative egress route in case of an emergency. We have developed a scope of work and anticipate that evaluating the landslide will cost between about \$18,000.00 to \$22,000.00. Please contact us to prepare a formal agreement when ready to proceed with an evaluation of the landslide.

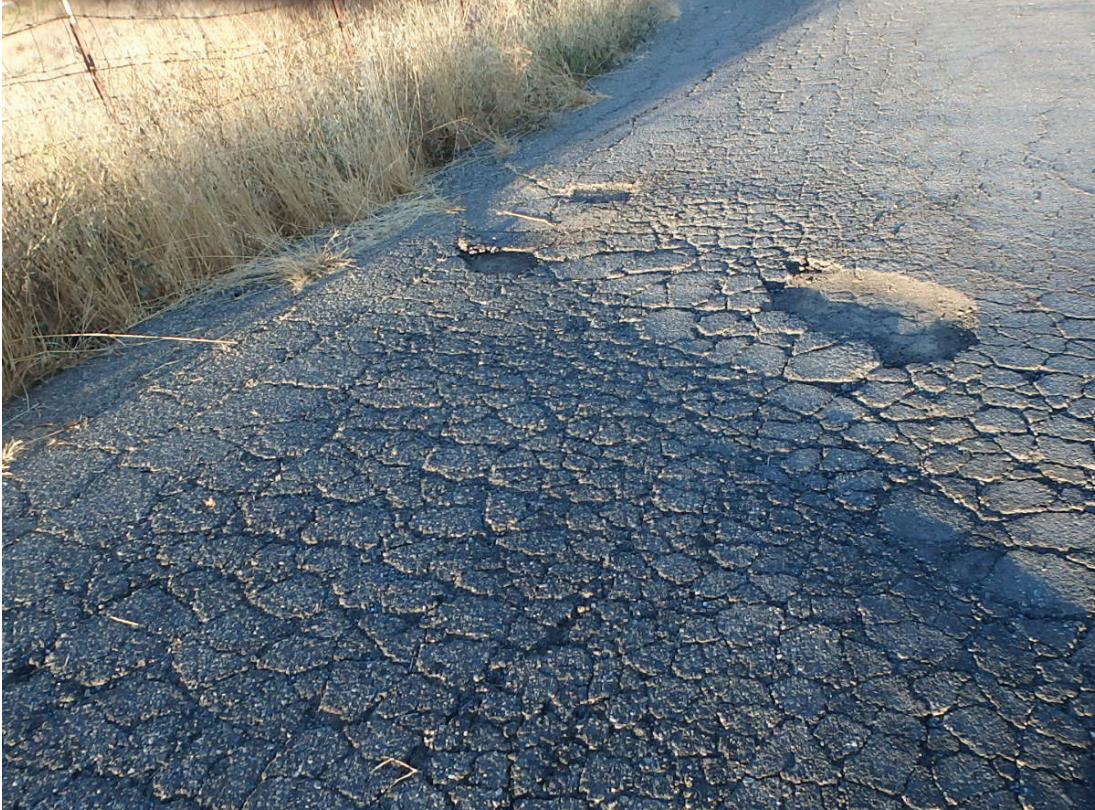
The subject roadway has been informally differentiated into five roadway segments, designated A through E, as illustrated on Figure 1, Roadway Site Plan. On 13 October 2023, our principal engineer/geologist and Mr. Velimir Sulic observed the roadway conditions along several of the roadway segments, and after which we met with you. The majority of the roadways we observed were significantly deteriorated with wide spread alligator type cracking and spalling of the upper asphalt overlay. Examples of the deterioration are shown on Photos 1 and 2.

The pervasive presence of alligator cracking and asphalt spalling is indicative of bearing capacity failure of the subbase and/or subgrade material underlying the asphalt. To rectify this condition, the existing asphalt should be removed and the underlying subgrade be scarified and recompacted to at least 90% relative compaction by the Modified Proctor Test method, in general accordance with the ASTM Test Designation D1557 (latest revision). Following recompaction of the subgrade, a minimum of 6 inches of CalTrans Class II baserock should be placed and compacted to 95% relative compaction prior to placing asphalt. The asphalt pavement section should adhere to accepted industry standards and County requirements.

PHOTO 1: Typical roadway asphalt deterioration. Note “alligator” crack pattern and spalling of the upper asphalt overlay.

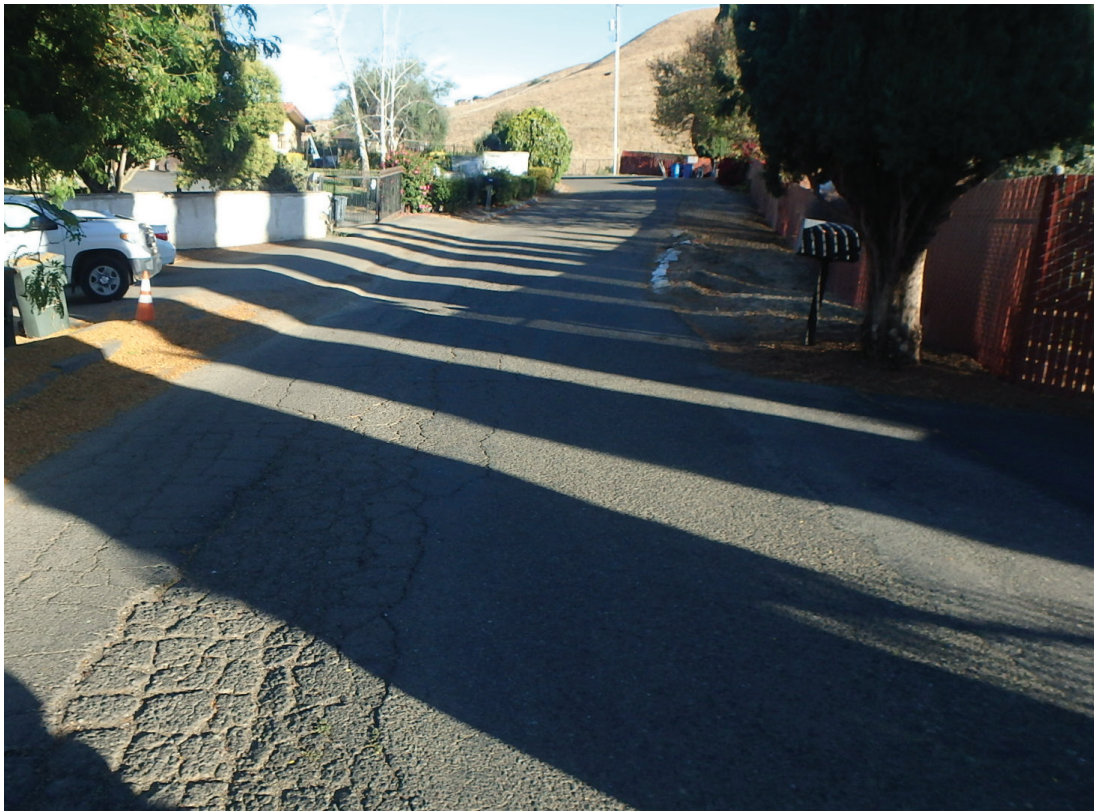
The roadway does not appear to have been constructed with drainage facilities that meet current standards of practice. We understand that the area in the vicinity of Photo 2 consistently accumulates water during rain events. Drainage improvements are being considered to collect and direct surface runoff into Flint Creek.

PHOTO 2: Area where water ponds. Also, note deteriorated roadway asphalt.

The drainage system along the roadway should be evaluated and redesigned by a civil engineer. In general, collected water can be discharged to Flint Creek, provided that it is done in a manner that does not cause erosion or slope instability.
